**Pier 4 Phase 1
Removal Action Project**

**Time Critical Removal
Action Completion Report**

Port of Tacoma
P.O. Box 1837
Tacoma, Washington 98401

July 2016

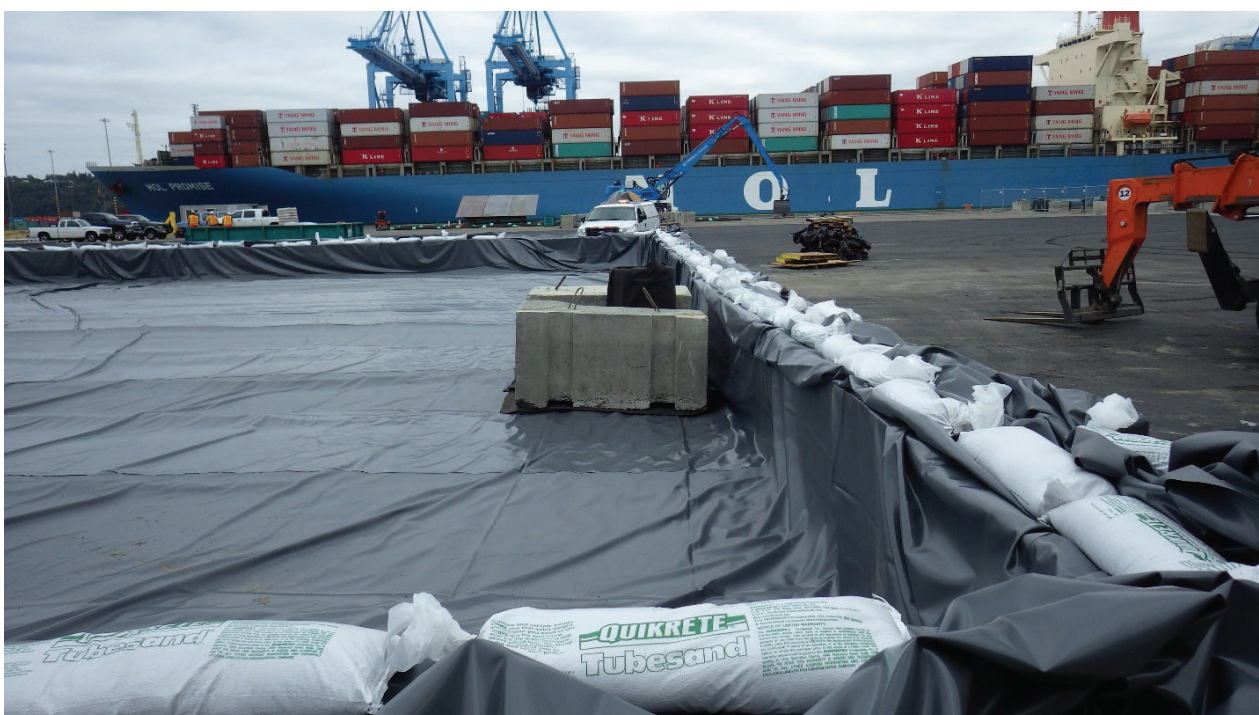
Photograph 20. Set up of the settling pond at APM Terminals.

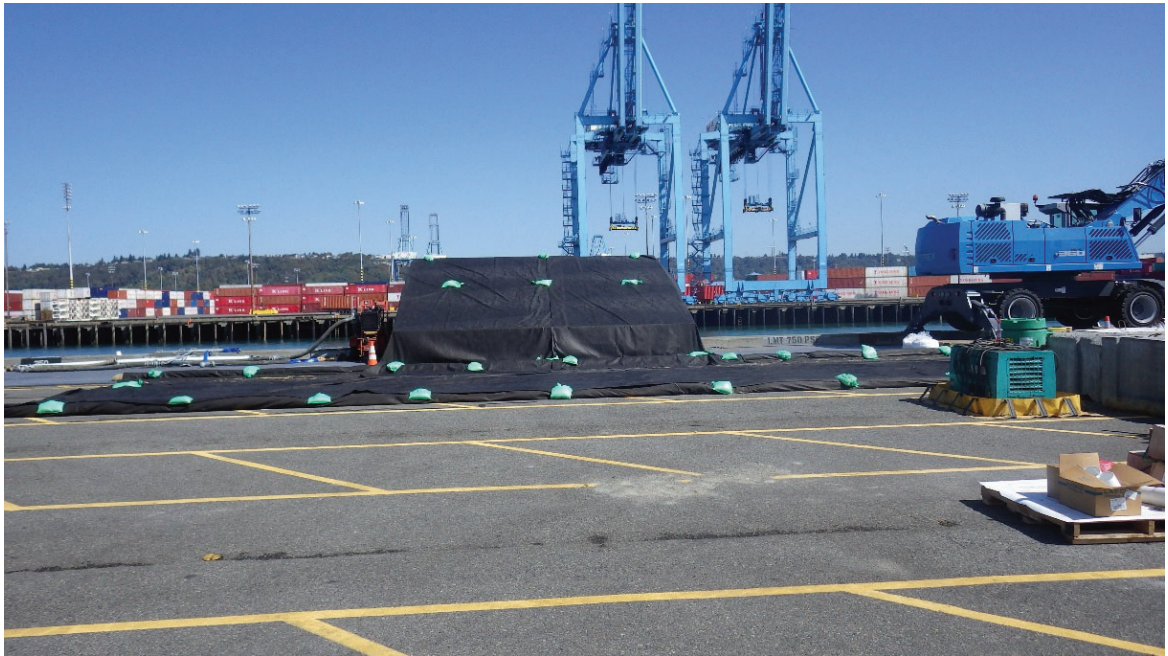
Photograph 21. Spill apron with filter fabric adjacent to edge of pier at APM Terminals.

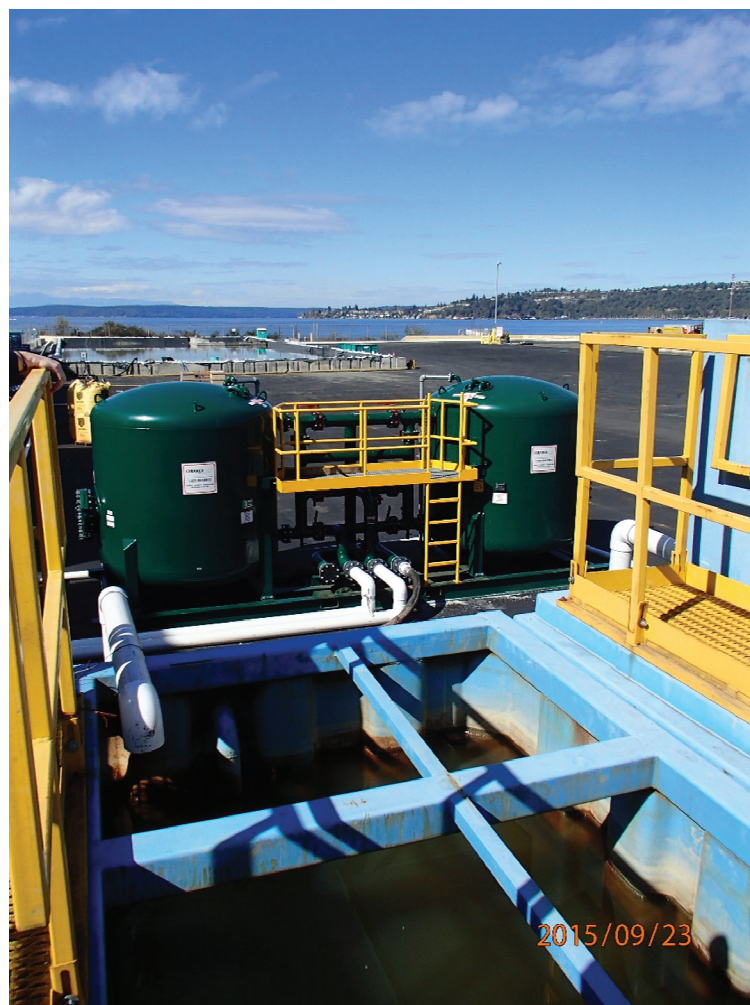
Photograph 22. Water treatment system and GAC filters at APM Terminals.

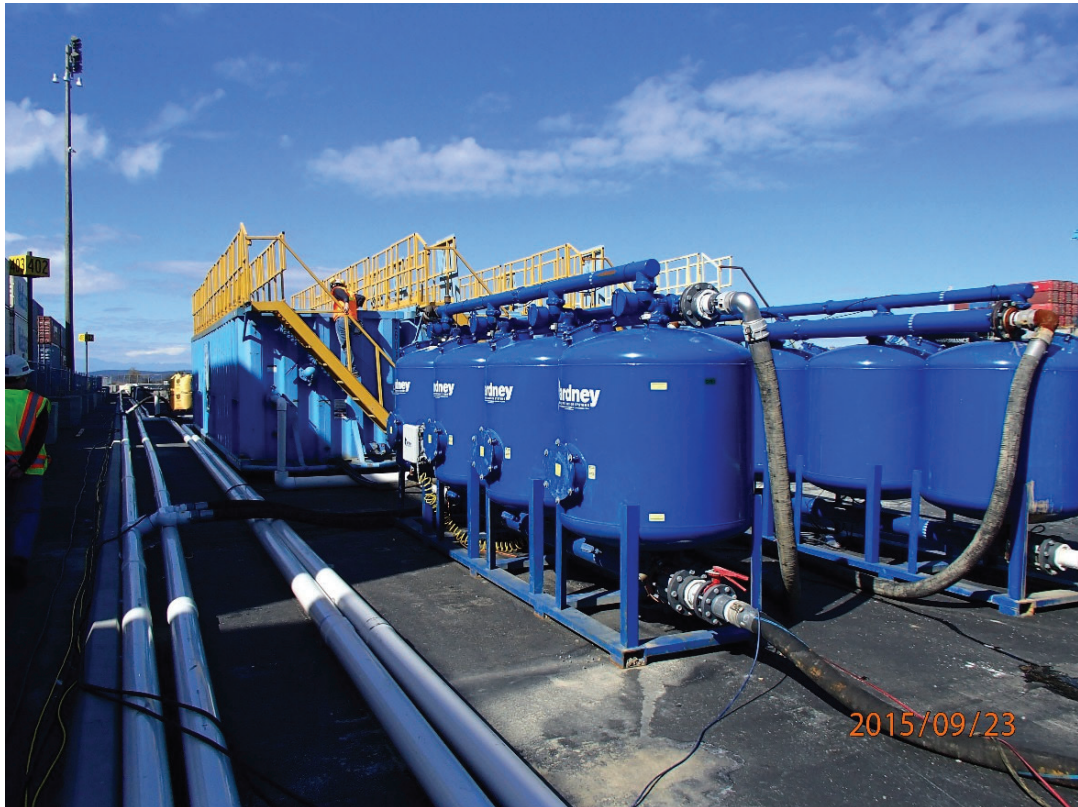
Photograph 23. Water treatment system media filters and weir tanks at APM Terminals.

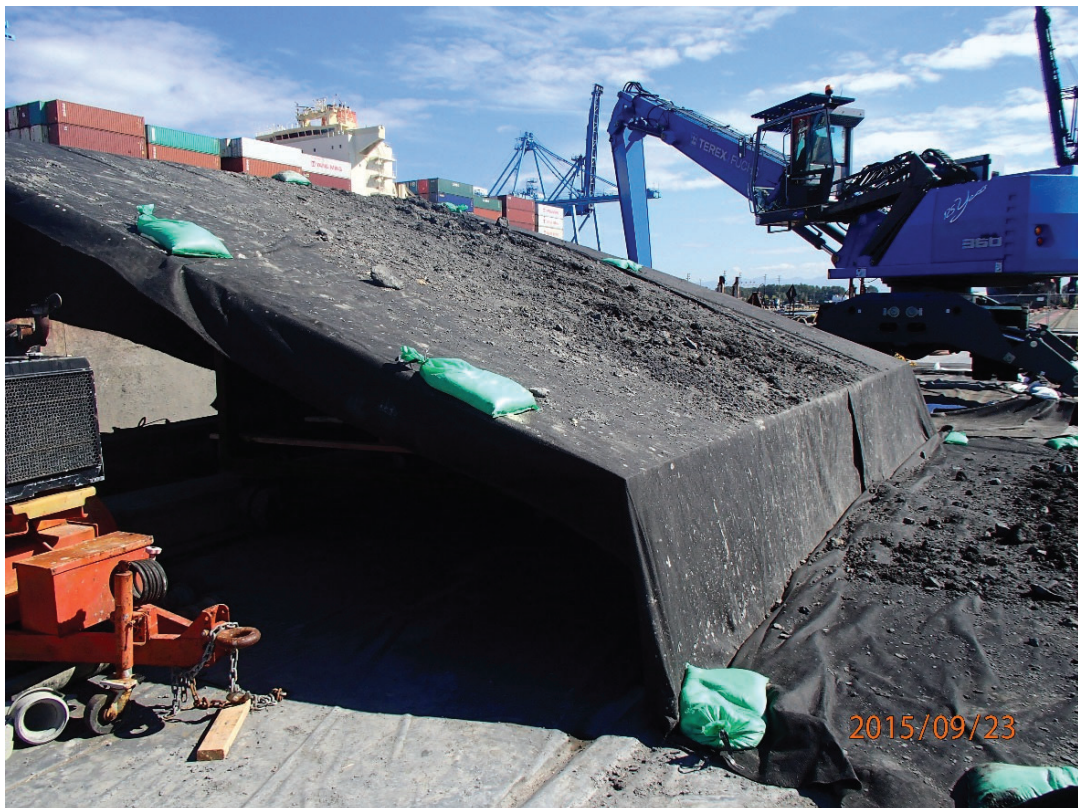
Photograph 24. Accumulated sediment on spill apron at APM Terminals.

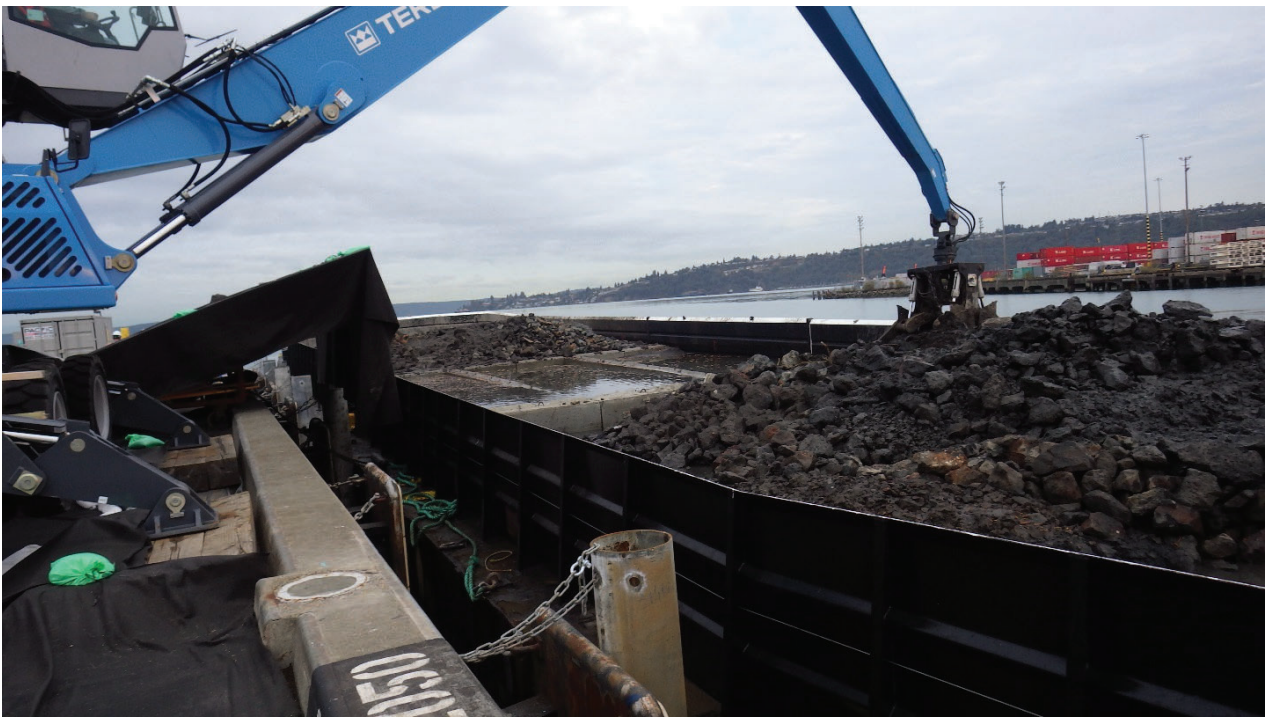
Photograph 25. Transloading of sediment and rock armoring at APM Terminals

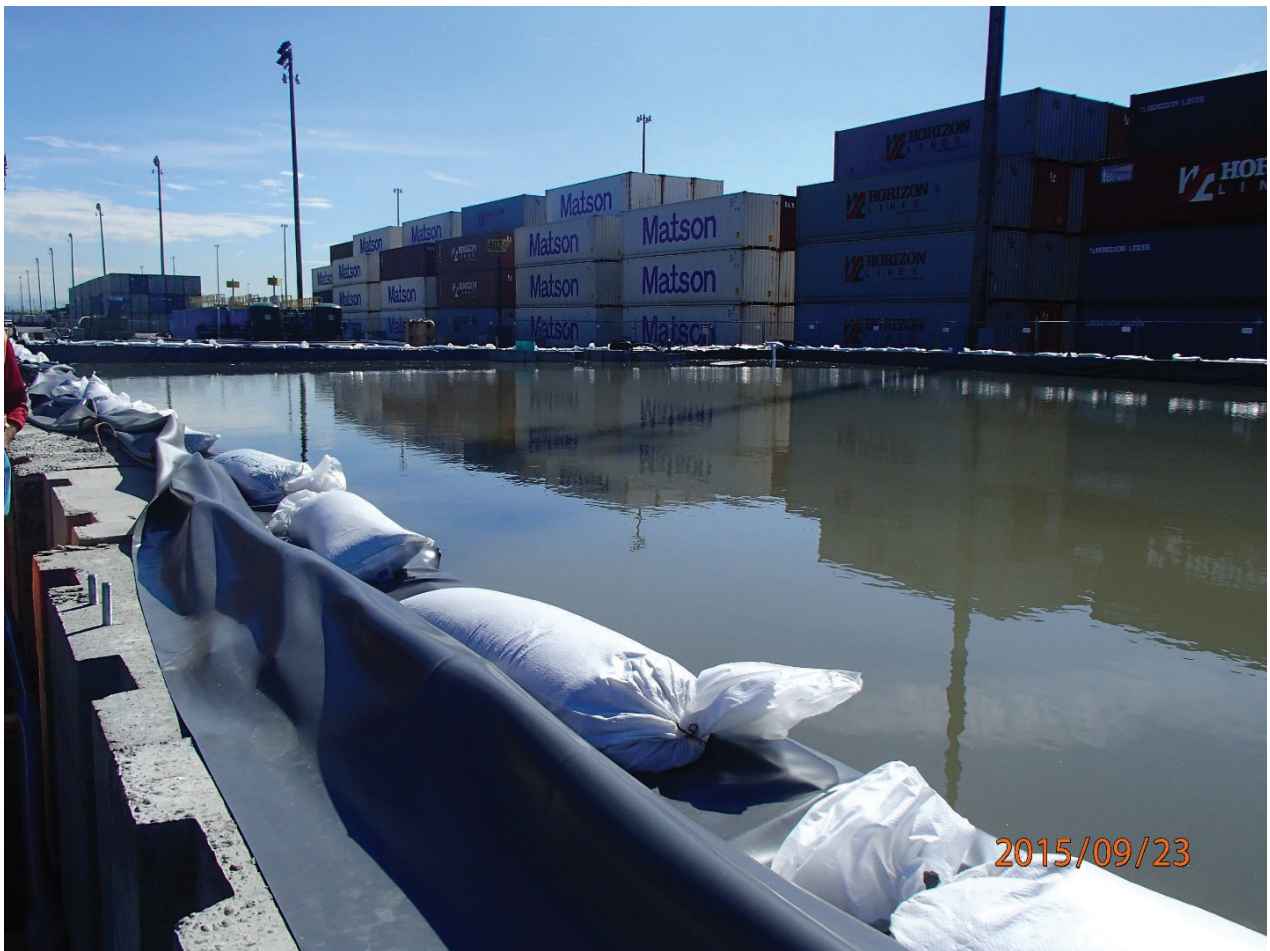
Photograph 26. Accumulated water in the settling pond at APM Terminals.

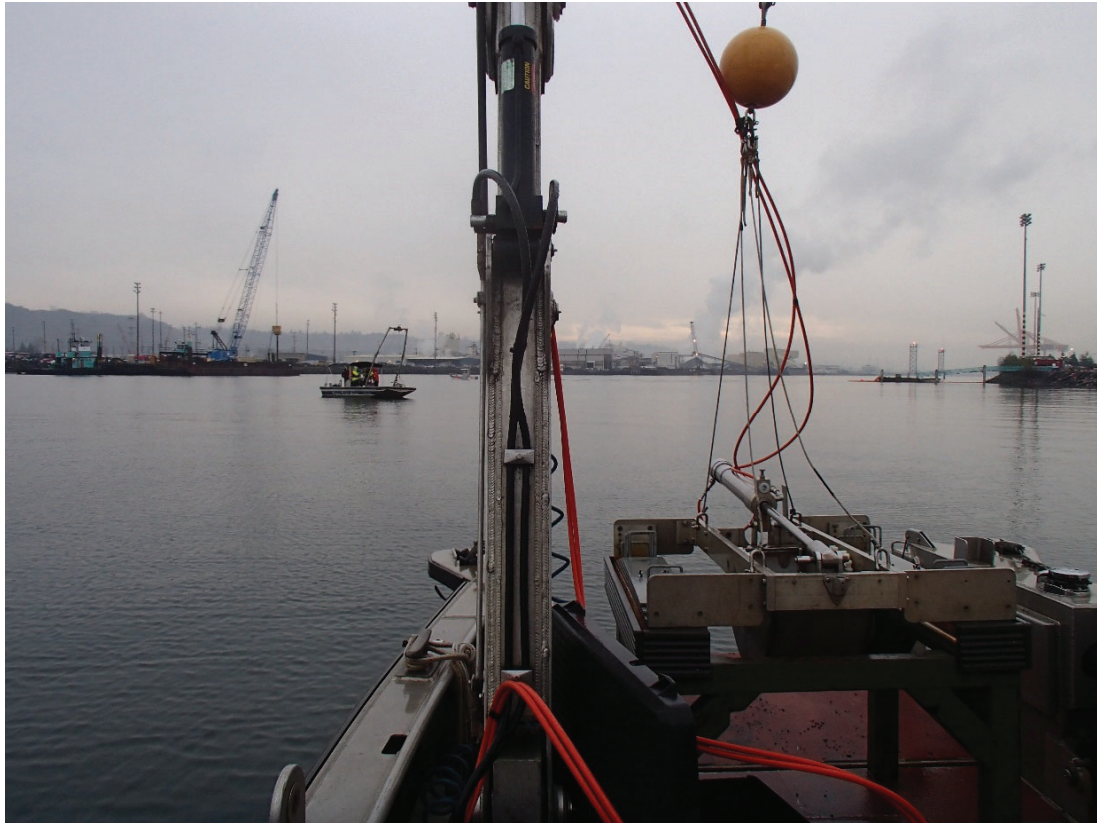
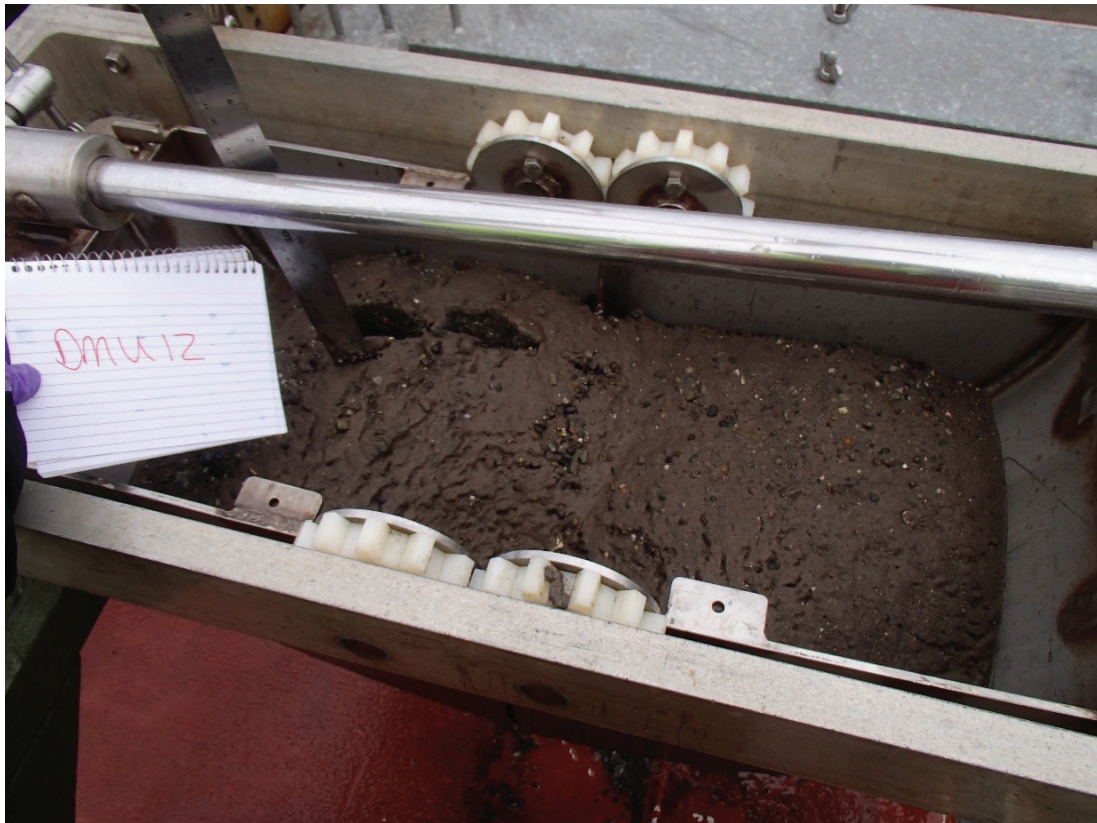
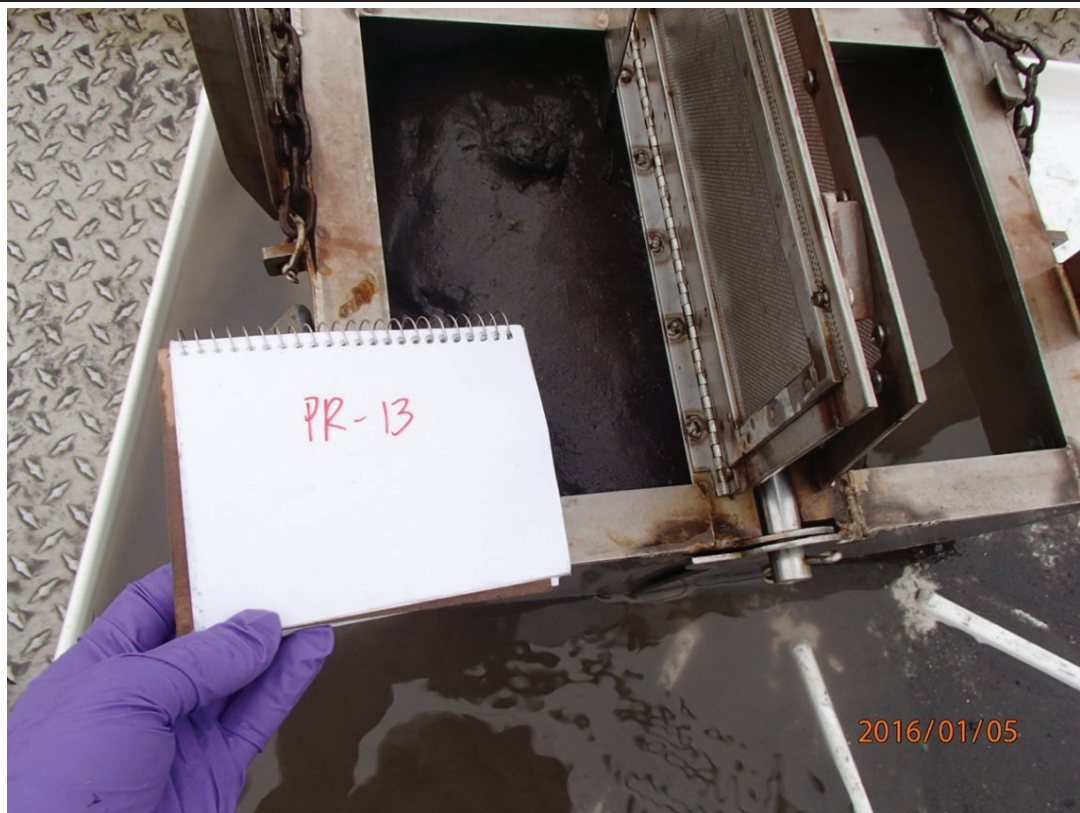
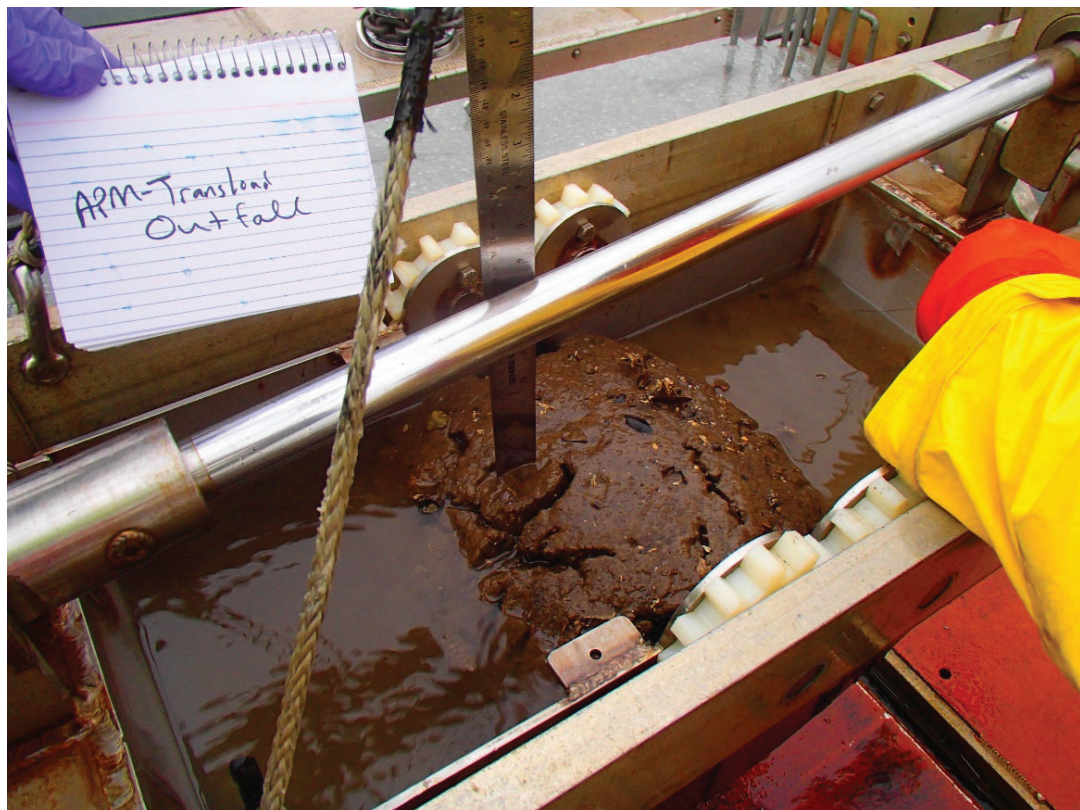
Photograph 27. Sediment sampling during first event.

Photograph 28. Power grab sediment sample at DMU-12 during first sampling event.

Photograph 29. Van Veen sediment sample at PR-13 during first sampling event.

Photograph 30. Power grab sediment sample at the APM Terminals Transload outfall location during first sampling event.

Sediment observed in the majority of the grab samples was dark gray, poorly graded fine to medium sand and silty sand. Many of the sample grabs were overlain by a fine brown silt layer that was presumed to be dredge residuals, although there was no correlation between the presence of the surface silt layer and TBT concentrations. No odor or anthropogenic debris were noted.

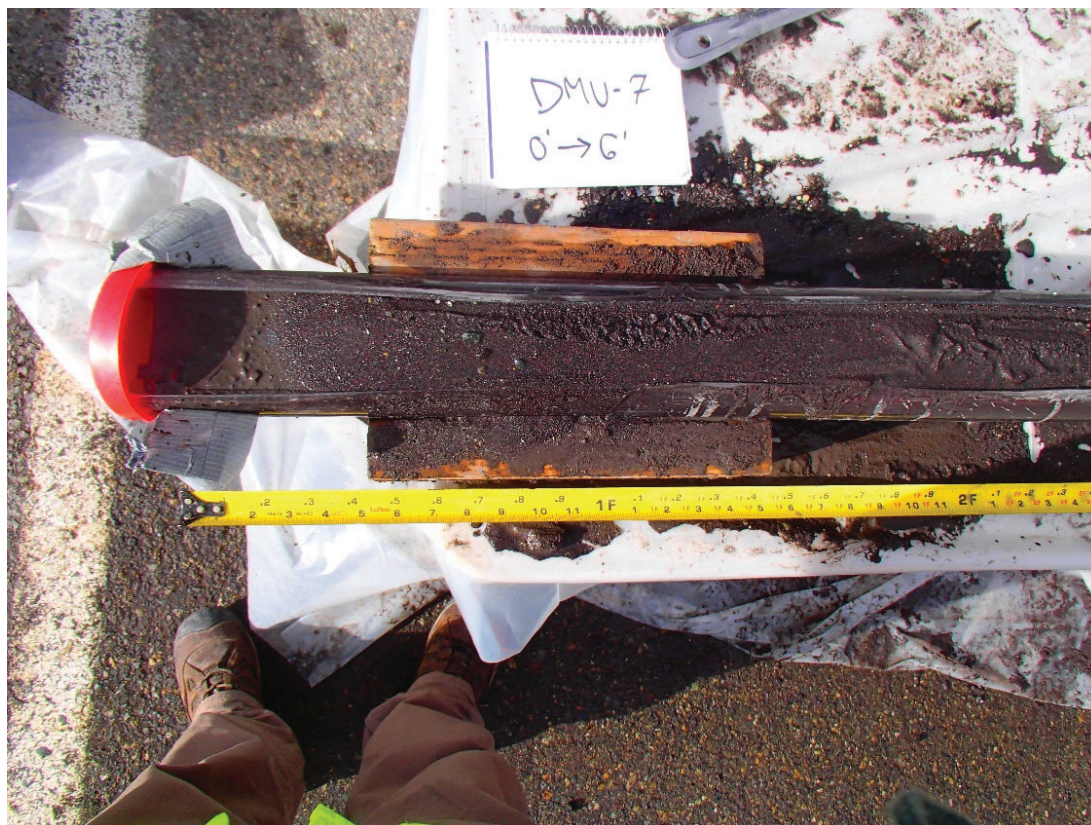
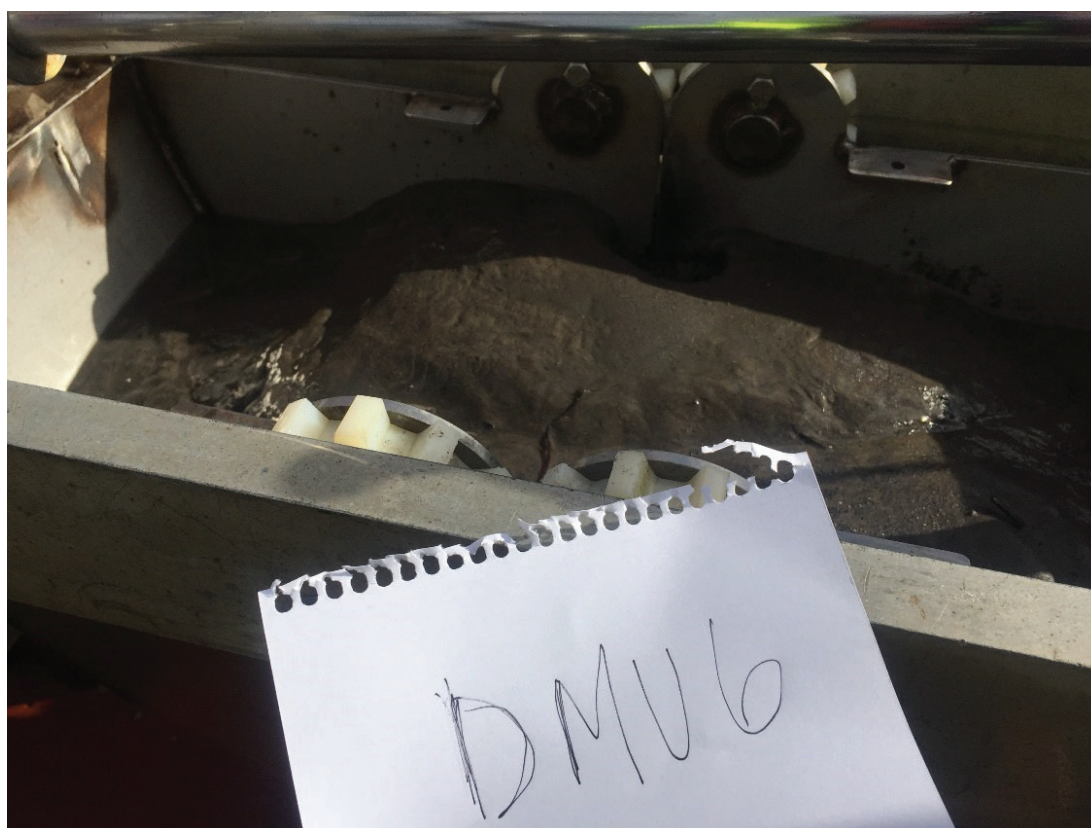
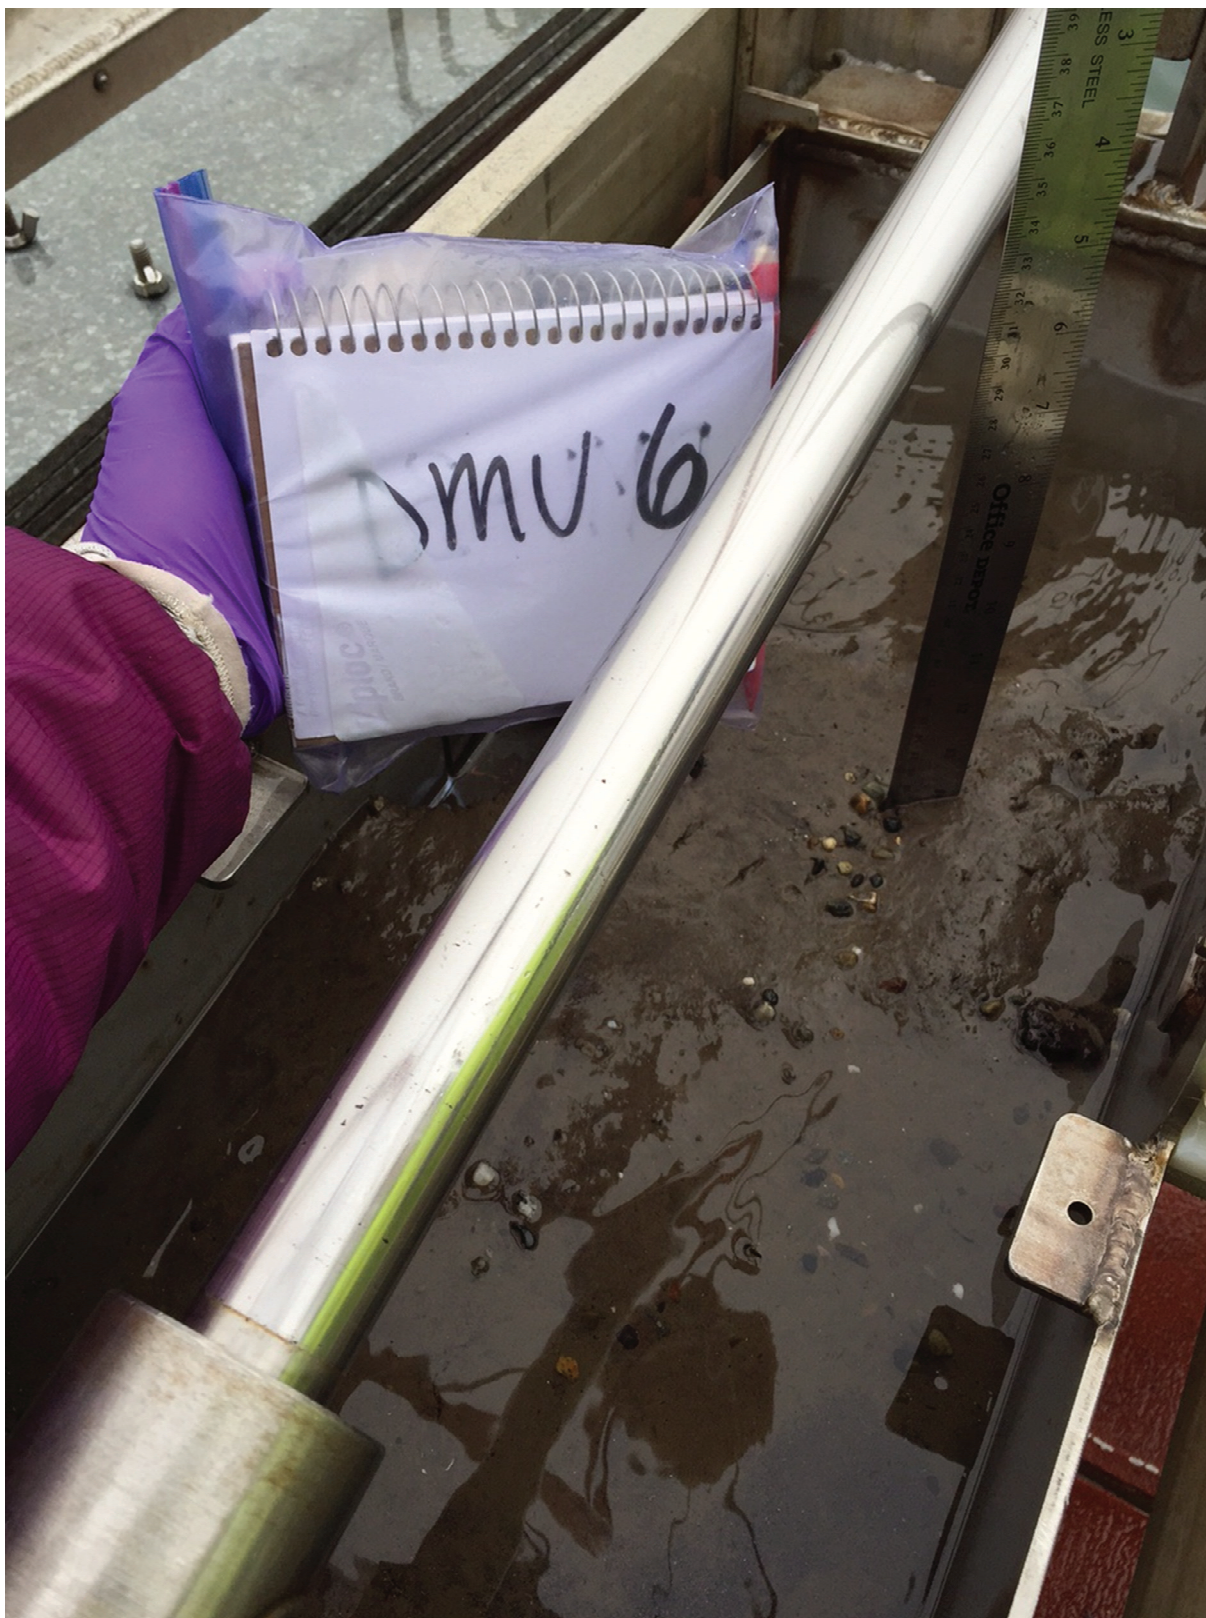
Photograph 31. Sediment core from DMU-7 during second sampling event.

Photograph 32. Power grab sediment sample at DMU-6 during second sampling event.

Photograph 33. Power grab sediment sample at DMU-6 during final sampling event.
